Top2Bottom Home Inspection

\$ClientName1 \$ClientName2 Property Inspection Report

123 Sample Street, Anytown, OK 99999

Date of Inspection: 5/24/2012

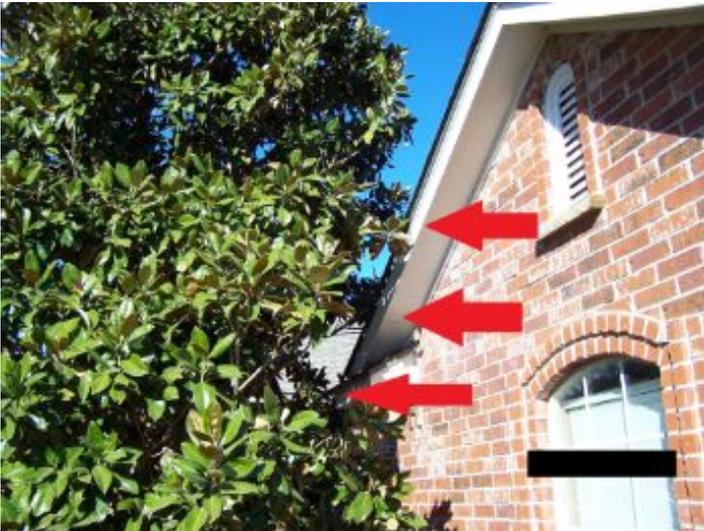
- Debris built up on roof. Limbs touch roof. Recommend trimming back as can cause early failure of roofing materials.

Trim Trees away from roof.

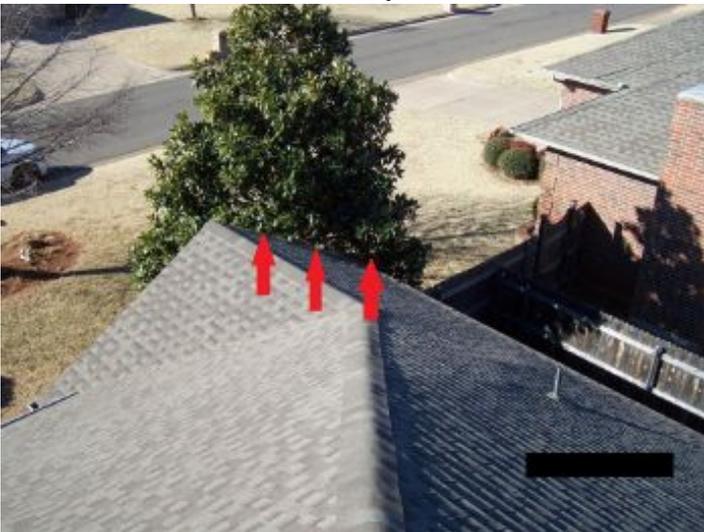
Tree: trim away from roofing (view from roof)

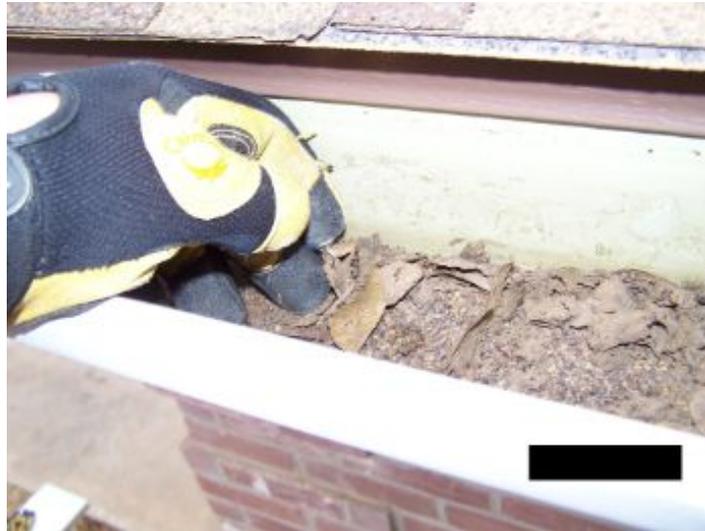
- Maintenance Tip: Keep gutters cleared of pine needles to prevent downspouts from being clogged and overflow at gutters.

Maintenance: Keep Gutters clean of debris to allow proper function

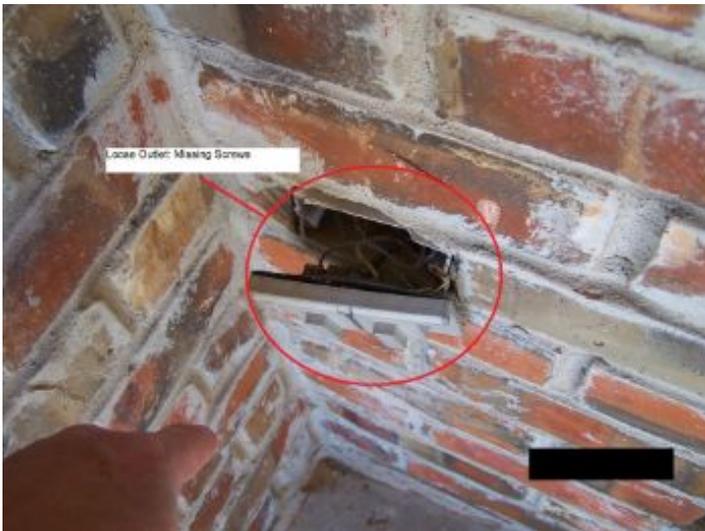
- **Electrical Outlet loose from mounting to House: recommend licensed contractor secure in mounting box to prevent possible shock or moisture entry.**
- **Electrical Extention Cord running from Garage to power of Sprinkler Control Box. GFCI Outlet adjacent to Sprinkler Control box has no power. Recommend Licensed Contractor / Electrician evaluate / repair GFCI outlet and remove extention cord. Extention cords are not meant for permanent installation.**

Missing Screws to Electrical Outlet (outside back door)

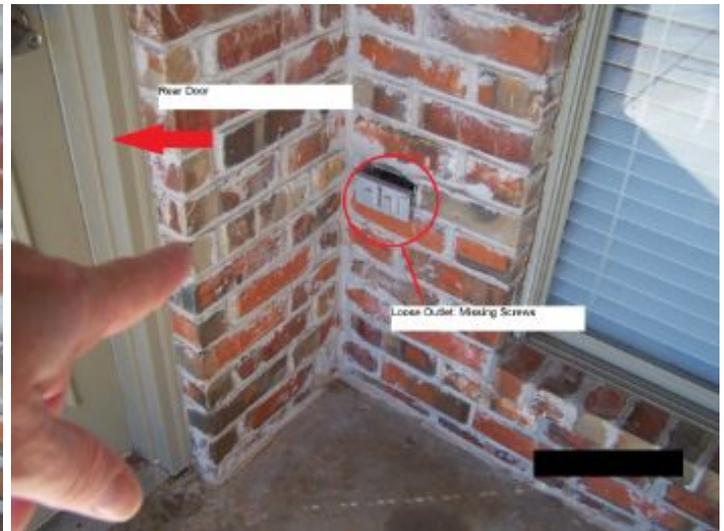
Missing screws on electrical outlet outside back door

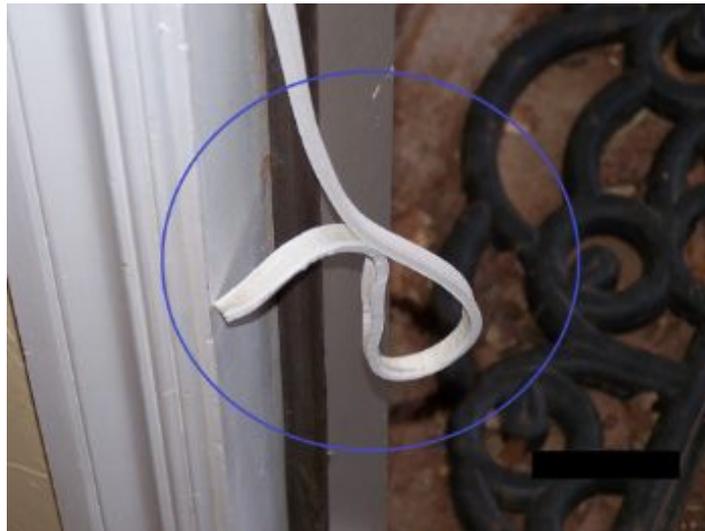
- Doorbell inoperative.
- Rear Door: Weatherstripping loose. Recommend repair / replace to prevent air / moisture intrusion.

Rear Door Weatherstripping

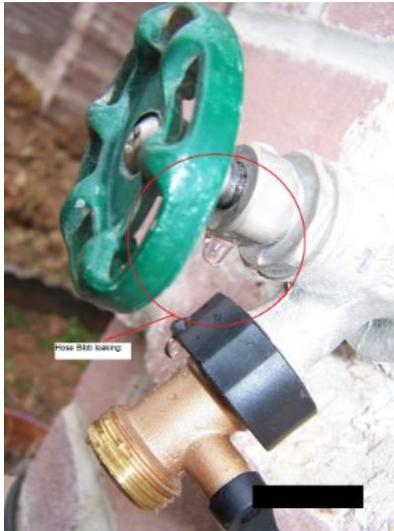
Observations: Hose Bibb Leaking at head: recommend licensed contractor evaluate for repair/replacement

Facet, Front of Home, leaking at packing nut

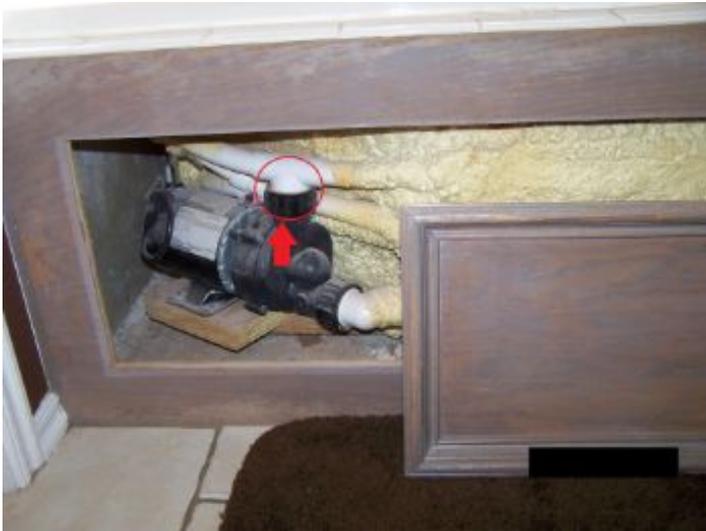
Jacuzzi Tub: Leaking at connection joint under tub. Recommend licensed plumber evaluate and repair.

Jacuzzi Tub Leaking at connection point

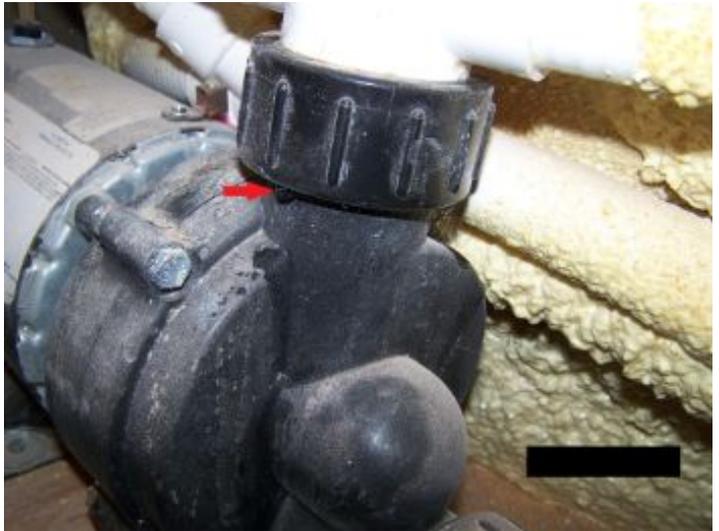
Jacuzzi Tub Leaking at connection point

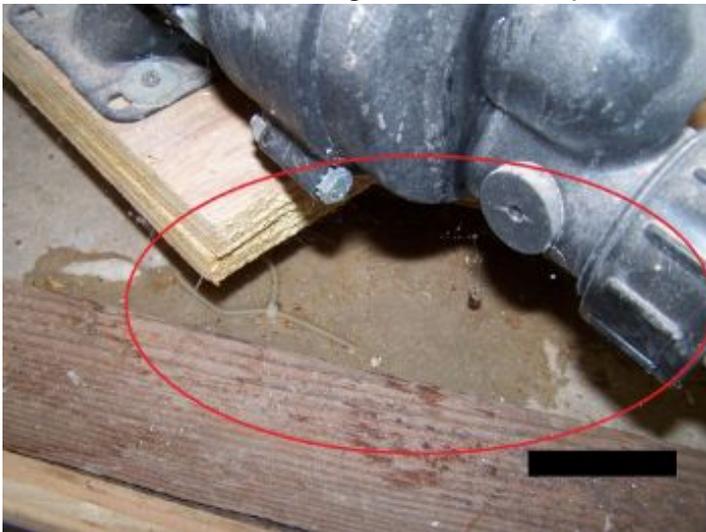
Jacuzzi Tub Leaking at connection point

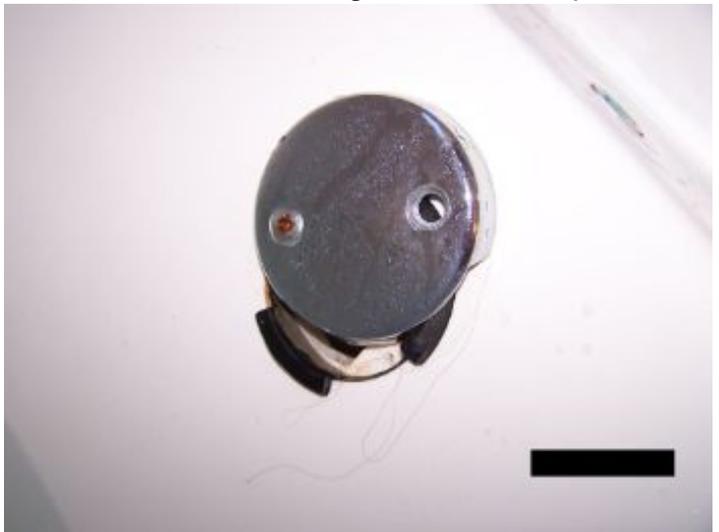
Master Bath Tub: Overflow drain cover missing screw. Recommend replacement to prevent possible water draining under tub.

Missing Screw on Tub Overflow

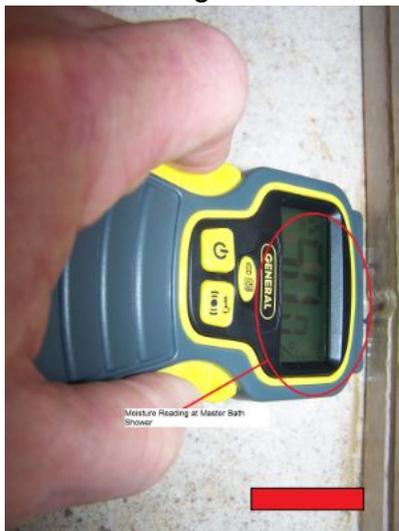
Shower: appears to be leaking at base as measured with Moisture Meter. Recommend licensed contractor / plumber evaluate and repair / replace as required.

Shower Pan indicates excessive moisture: Leaking

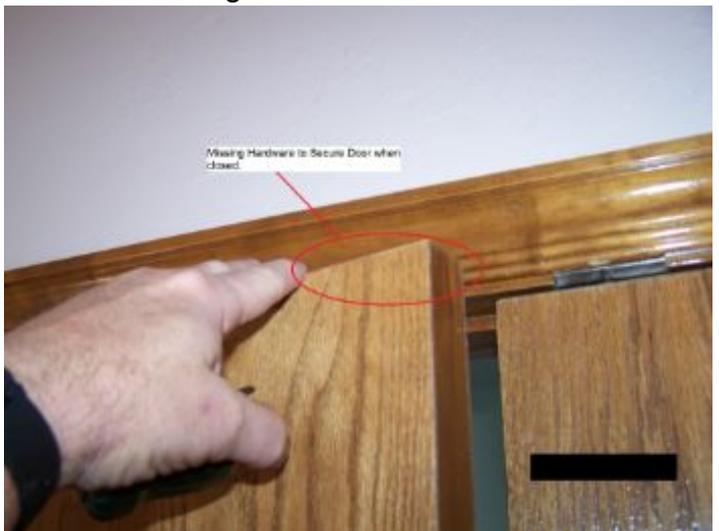
Missing Hardware Master Bath Door

- Master Bath Room Door doesn't latch properly: missing hardware on top left door. Hardware may be obtained at Home Depot, Lowe's, Ace Hardware, etc...

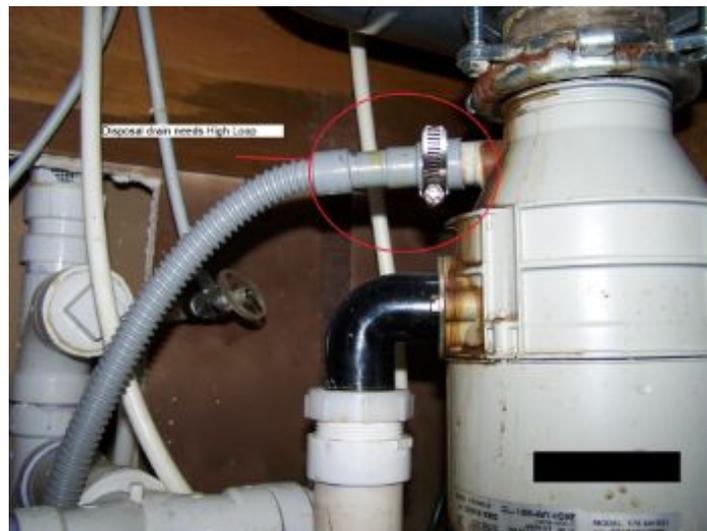
Dishwasher drain line to Disposal: No Hi Loop. Recommend attaching drain line to bottom of counter top to prevent "Gray" water from possible back flow.

Dishwasher Drain line at disposal: no high loop

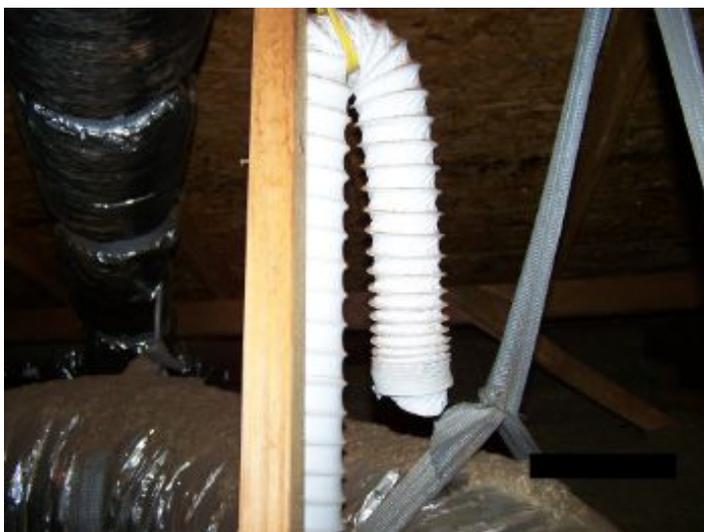
- Gas Line present in Laundry Room with Cap: not tested.
- **Dryer Venting into Attic: recommend venting to exterior of home to prevent lint and moisture venting in Attic.**
- **Dryer Vent large amount of lint: recommend cleaning.**

Dryer improperly venting into Attic space

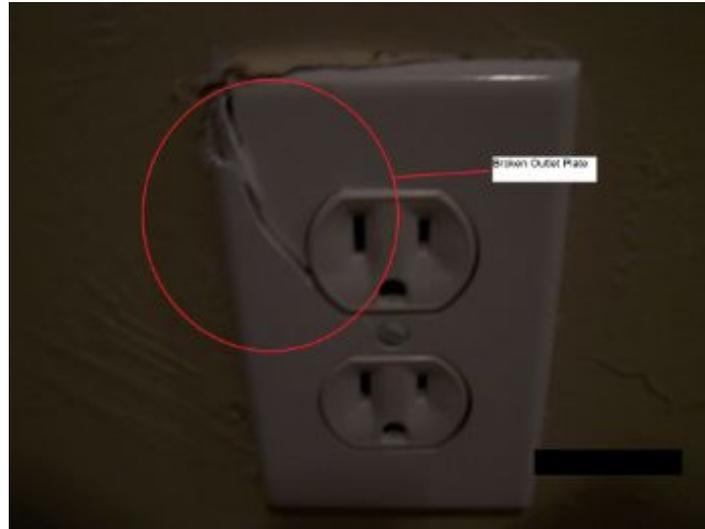
Outlet cover(s) broken: recommend replacement to prevent possible shock hazard.

Broken Outlet Plate

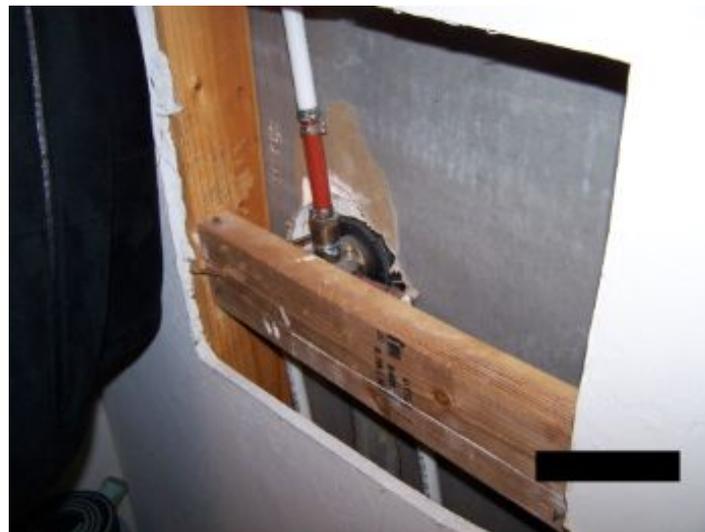
- Minor settlement cracks noted, which is normal for a house of this age.
- Large hole / missing sheetrock in Master Bedroom Closet. Recommend licensed contractor repair.

Missing Sheetrock in Master Closet

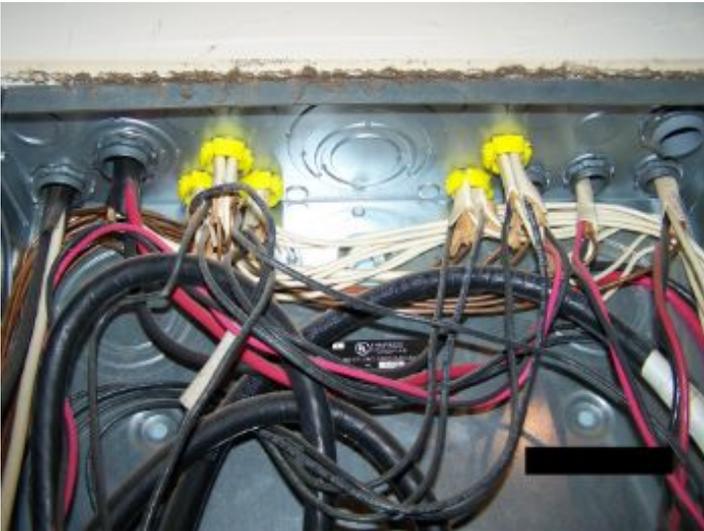
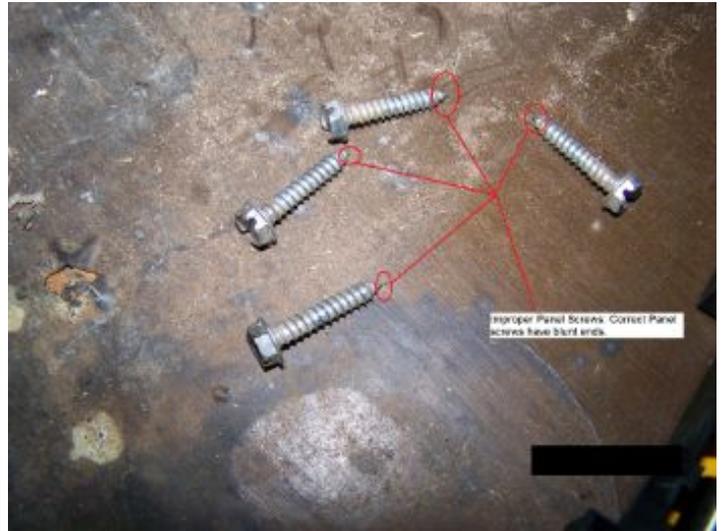
• **Sharp-pointed metal screws hold panel cover in place. These are a potential hazard as they may puncture wire insulation and electrify panel box, becoming a shock or electrocution hazard. Recommend Licensed Contractor replace with approved, flat-tipped panel screws.**

Improper Panel Screws in Electrical Panel

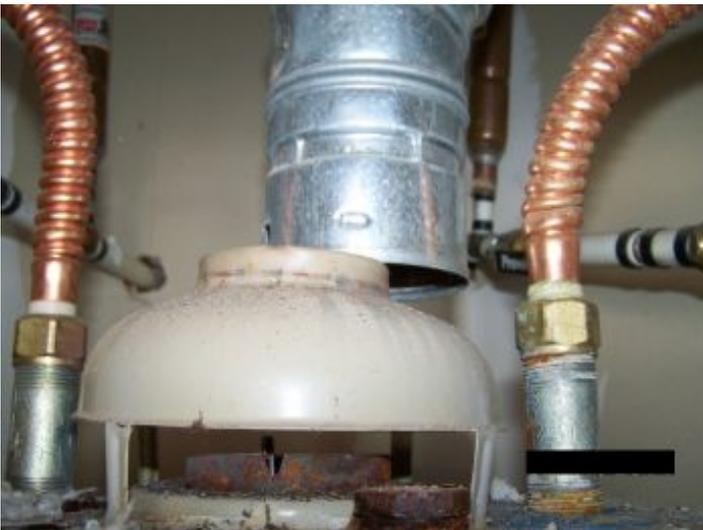
- **Flue Pipe of gas water heater loose: This should be attached properly direct carbon monoxide gases to exterior of home. This is a safety hazard.**

Exhaust Vent not attached: Safety Issue

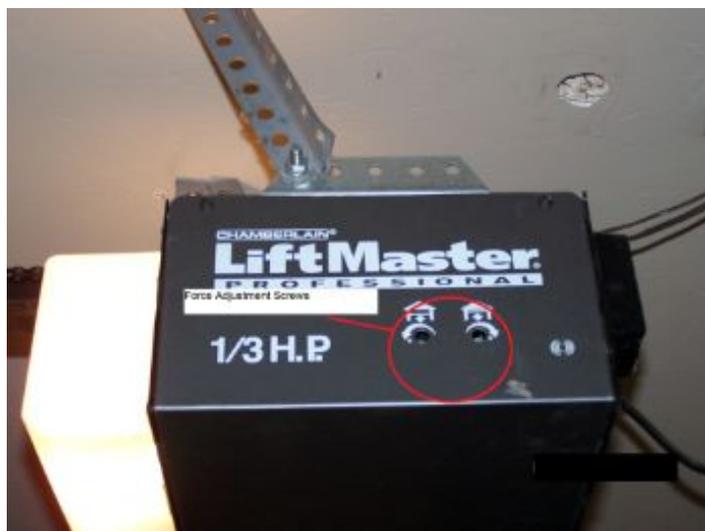
- Moderate crack(s) on garage floor. These should be sealed and monitored for expansion.
- **Garage Door Sensors: Up force, down force and impact stop needs adjustment to prevent possible vehicle damage or safety. Recommend evaluation and adjustment by Garage door technician.**

Up and Down force of Garage Door Opener Improper

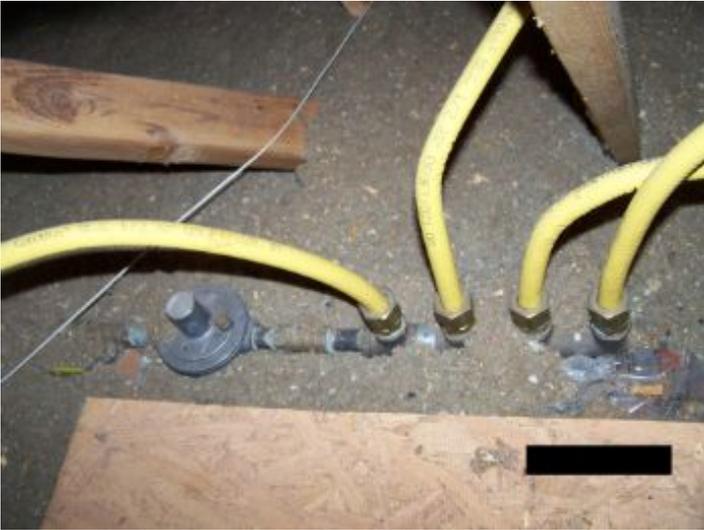
- Much of Attic is not visible due to insulation.
- Insulation averages about 8-10 inches in depth
- **Corrugated Stainless Steel Tubing, CSST, was observed and proper bonding could not be determined by inspector at time of inspection: "Manufacturers believe the product is safer if properly bonded and rounded as required by the manufacturer's installation instructions. Proper bonding and grounding of the product CAN ONLY be determined by a licensed electrical contractor".**
- **Wire ends are outside of a Junction Box, which is a potential shock or electrocution hazard.**

CSST Gas line present in Attic: Must be Properly bonded electrically
